Big Willow Creek Watershed (17050122SW17)

Total Maximum Daily Load

Implementation Plan for Agriculture

August 30, 2010

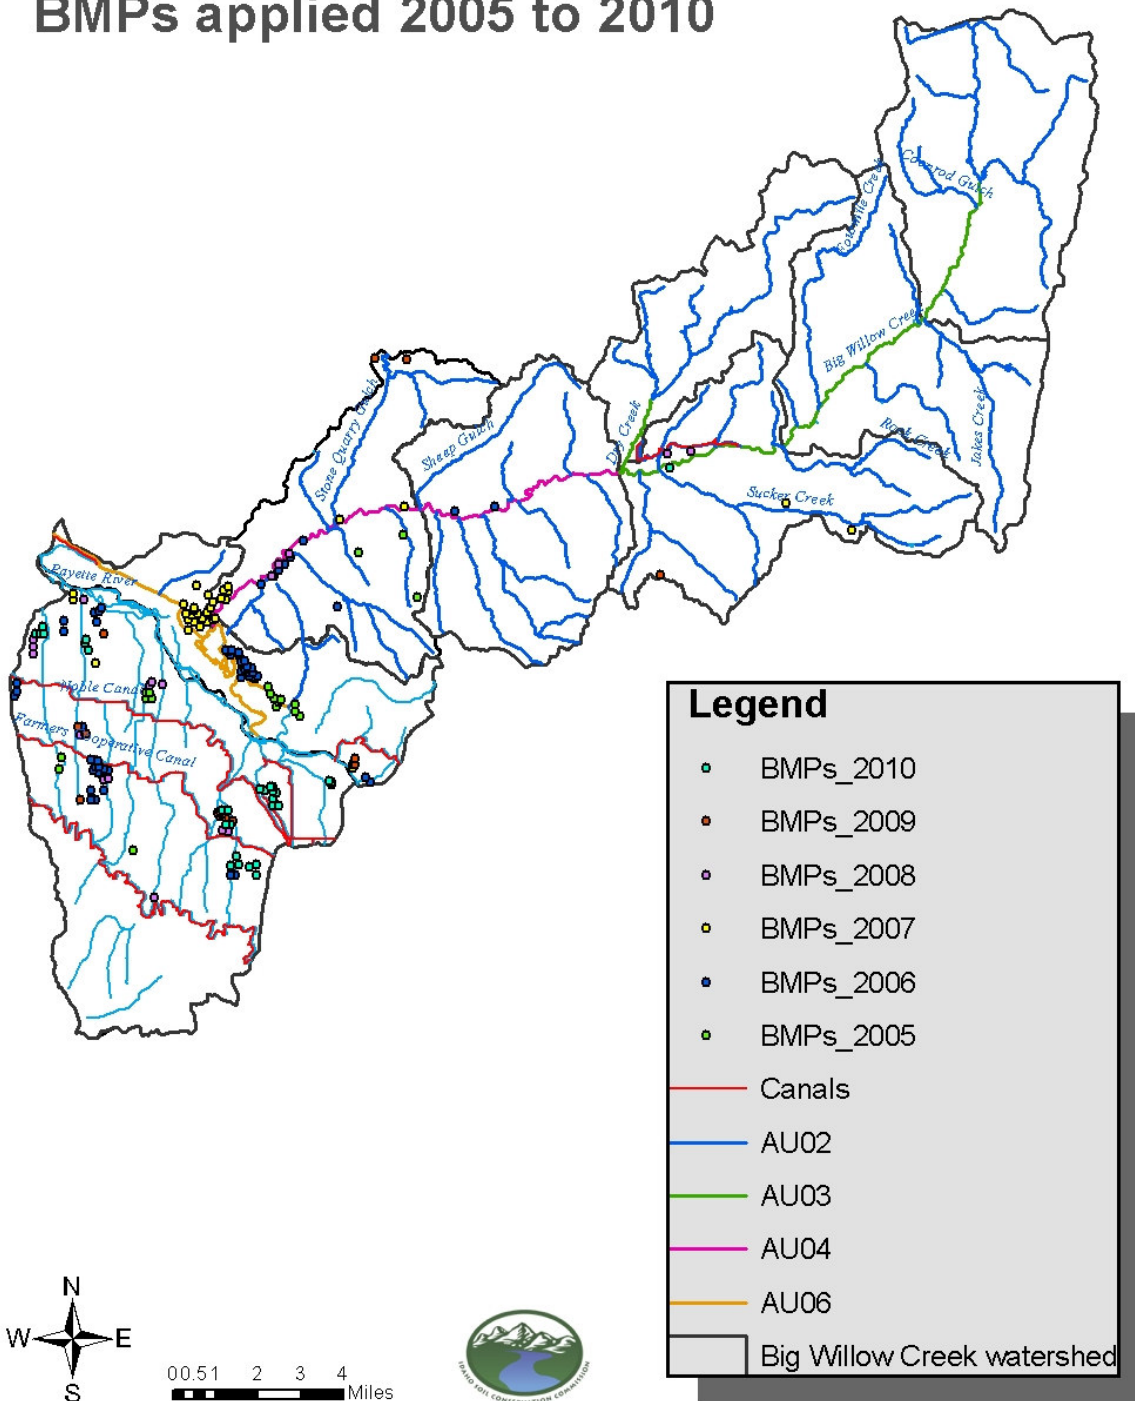
Figure 5. Federal BMPs implemented in the Big Willow Creek watershed, by year

Big Willow Creek watershed BMPs applied 2005 to 2010

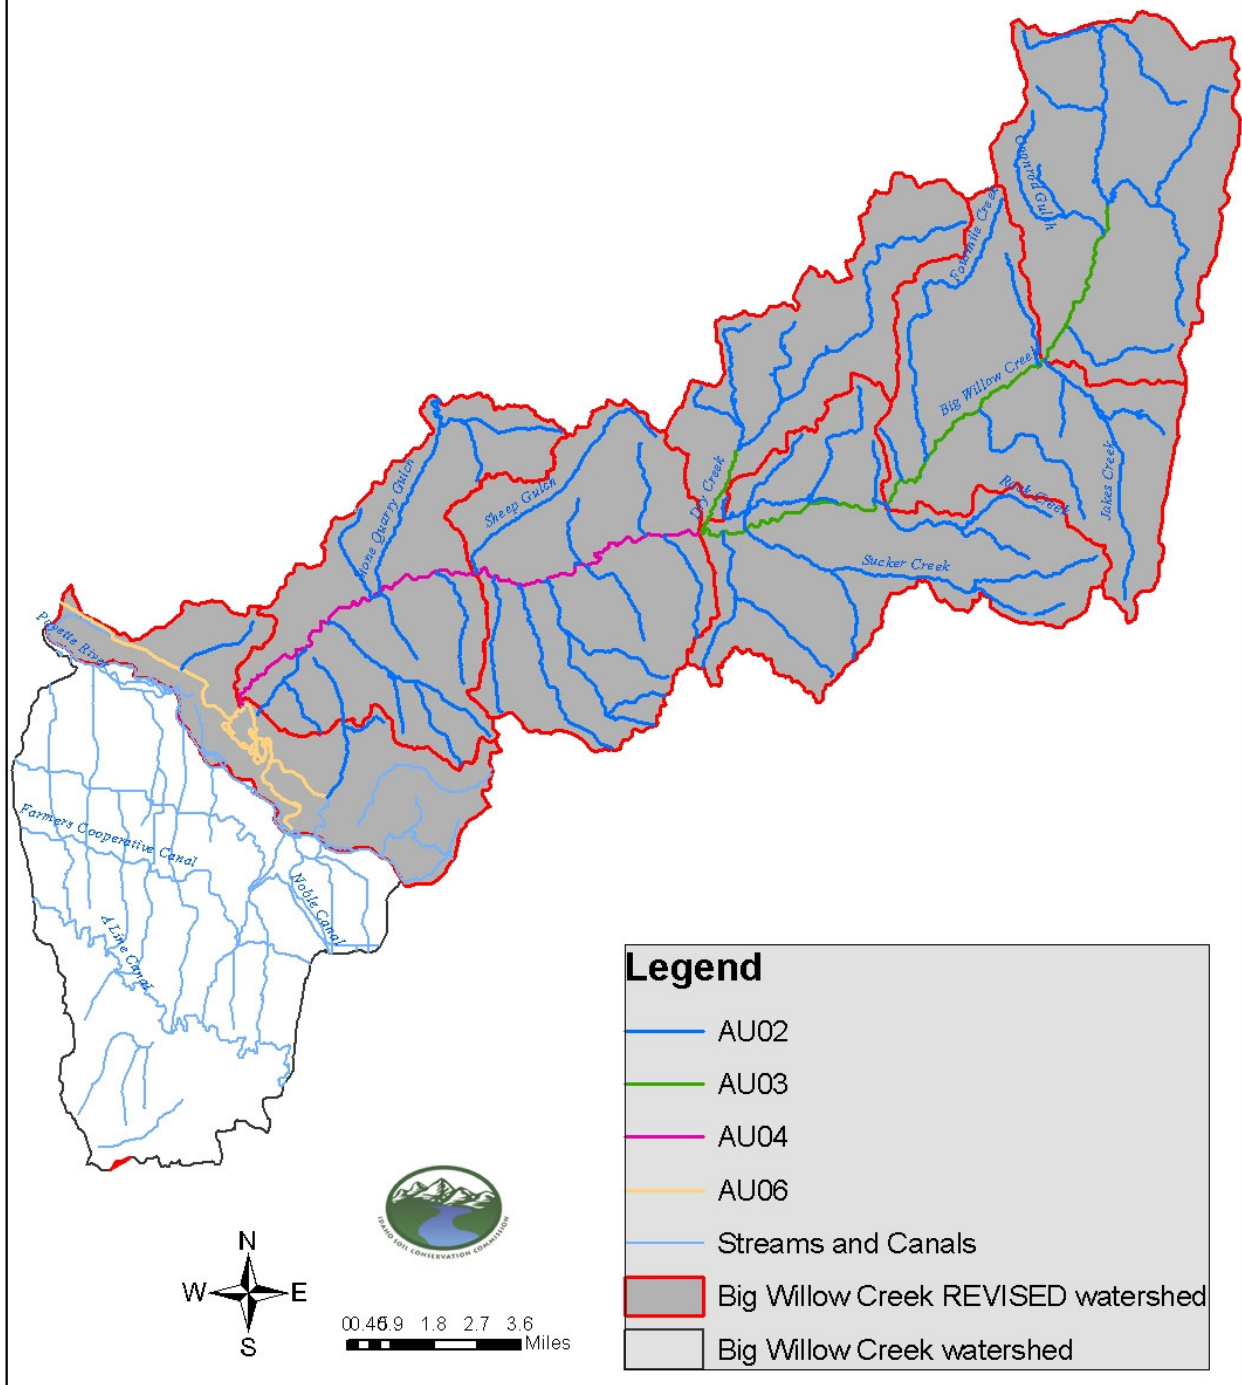
Figure 7. Proposed subwatersheds for BMP implementation in the Big Willow Creek watershed

Big Willow Creek Proposed subwatersheds for implementation

ArcView GIS 9.3 software, NAIP imagery, topographic maps, land ownership, cropland units, field investigations, previously treated areas, and DEQ shade analysis were used to delineate riparian areas that fall under a particular tier.
